EPOXYWORKS®

BUILDING, RESTORATION & REPAIR with EPOXY
Number 54 ■ Spring 2022

BO-PEEP II 75-Year Refit

Wet Rudder Repair

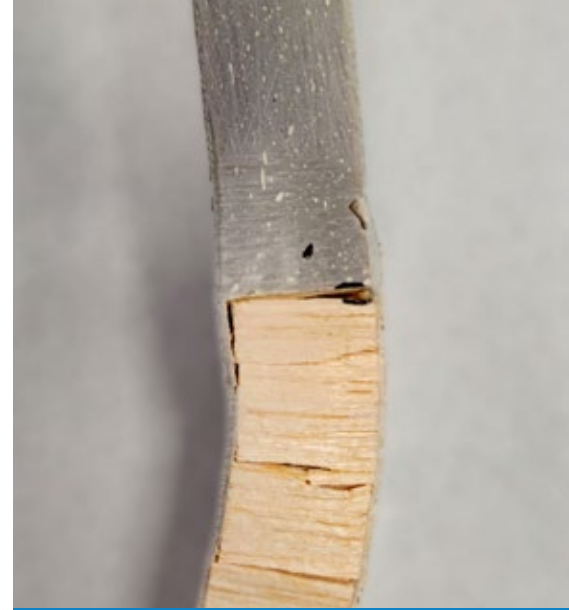
Another sample panel that broke at the repair joint was the one with thickened WEST SYSTEM Epoxy as the core replacement. Its fiberglass and balsa core fractured right at the transition from epoxy to balsa core. This break happened exactly where I thought it would; I just imagined it was going to be a more dramatic break than it actually was.

Close-up of the epoxy filled repair. Its fiberglass and balsa core fractured right at the transition from epoxy to balsa core.

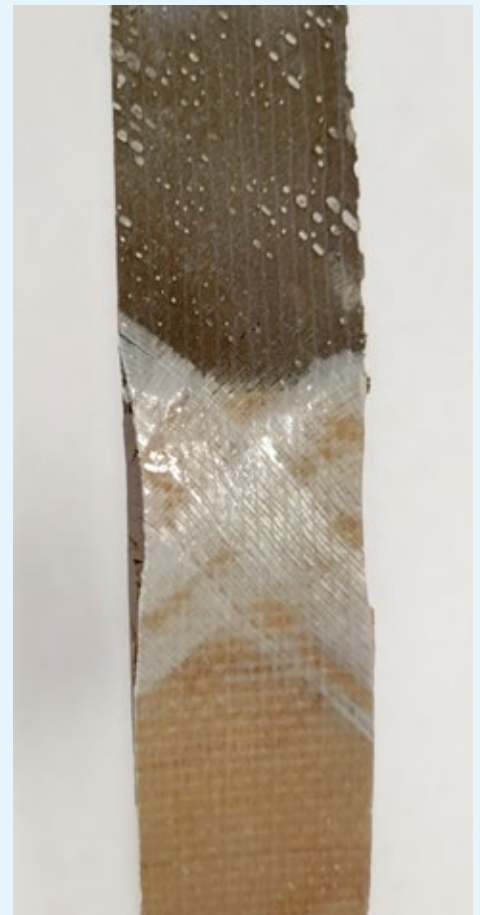
The fiberglass fractured in compression at the transition from epoxy to balsa core in the epoxy-filled repair.

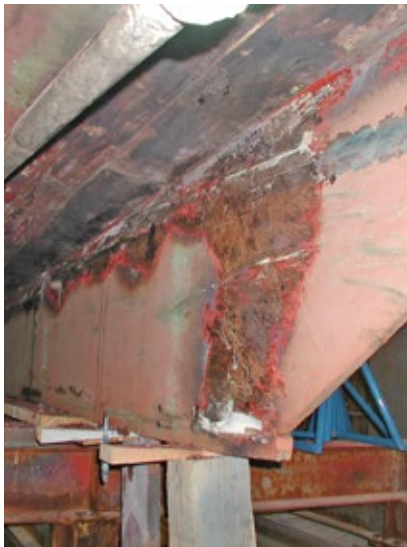
1989 keel check with epoxy repairs still good.

These defects were mainly the result of poor performed repairs. The era of the previous repairs could be identified by shipwright techniques and material types. But the repairs Rick Ryan had made in 1989 with WEST SYSTEM Epoxy were still holding strong in 2000.

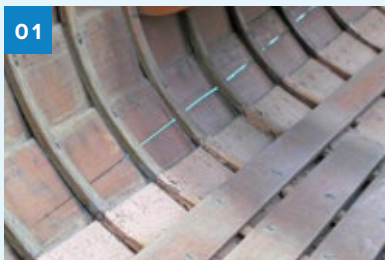
01
On the truck to Seattle, *BO-PEEP II*'s tender had suffered split planks in both bilge turns. The planks were also checked and had long gaps, rendering the tender unseaworthy. I made a uniform cut in each long split to clean out the damaged wood and inserted double overlapping graving pieces (sometimes called a Dutchman) with WEST SYSTEM 105 Resin®/205 Fast Hardener® thickened with 404 High-Density Filler.

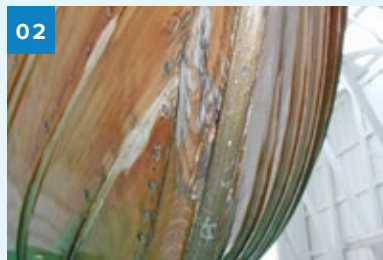
02
The original iron bolt in the oak stem had corroded and rotted the wood causing more small checks in the area. I carefully cut out the bad wood with a drill and chisel. Only a small amount of good wood remained, leaving the mortise in an irregular in shape. I used several small blocks of wood like a three-dimensional jigsaw puzzle to fill this void. When the thickened epoxy cured, I shaped the repair and installed a 316L stainless steel bolt.

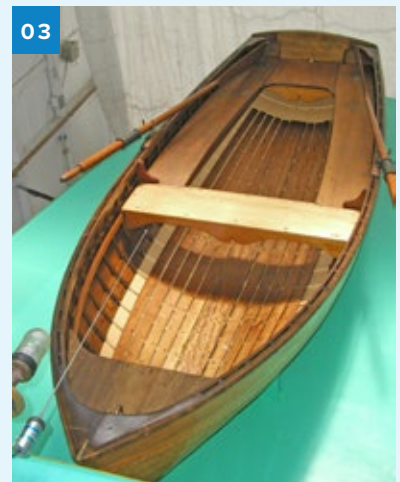
03
There were small checks in the planks joining the transom and keel. The keel had minor grounding damage. I simply reefed the checks slightly with my pocketknife and filled them with WEST SYSTEM 105/205 thickened with 404 filler.

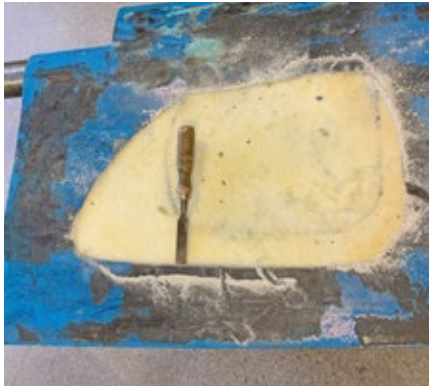
We found two smaller delaminated spots on one side of the rudder and a sizeable one on the other, along with a 6" crack near the rudder shaft. After drilling a few $\frac{3}{8}$ " drainage holes through the fiberglass skin and into the foam core, we saw that it was still in good shape even though the foam was wet.

Fiberglass removed from a section of the rudder.

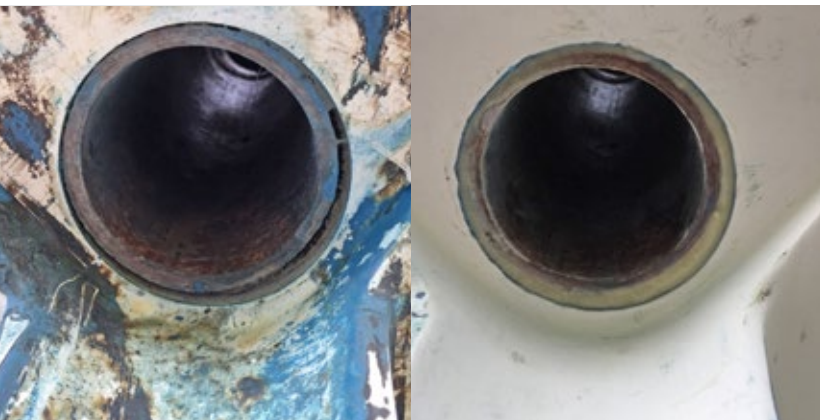
TOP: The rudder shaft before and after repair.

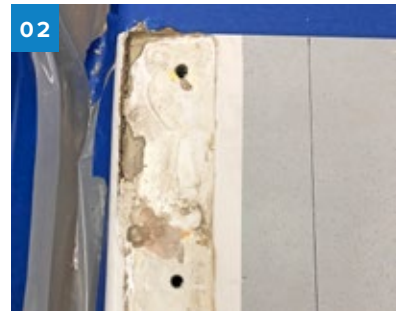
02 The aluminum brackets were removed to evaluate the damage.
