EPOXYWORKS®

BUILDING, RESTORATION & REPAIR with EPOXY
Number 54 ■ Spring 2022

BO-PEEP II 75-Year Refit

Wet Rudder Repair

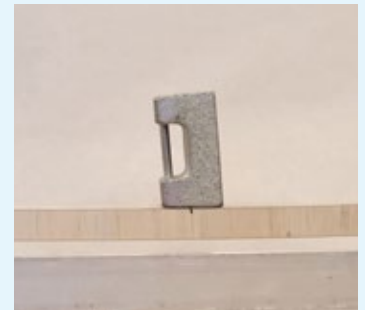
The end grain pine repair was only a little stiffer.

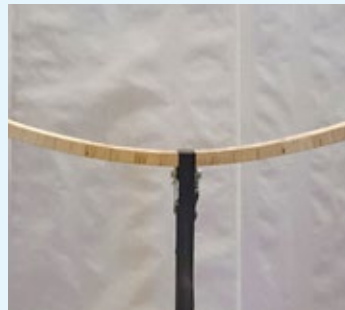
The pine repair broke where the balsa core met the pine.

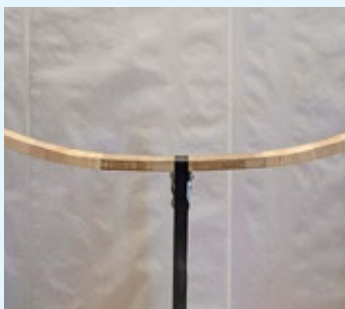
The plywood repair broke where the balsa and plywood met.

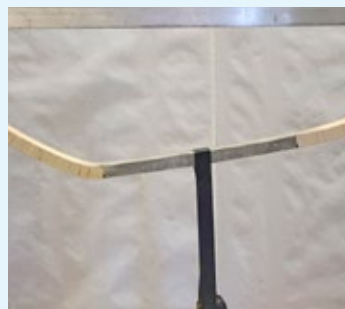
Another sample panel that broke at the repair joint was the one with thickened WEST SYSTEM Epoxy as the core replacement. Its fiberglass and balsa core fractured right at the transition from epoxy to balsa core. This break happened exactly where I thought it would; I just imagined it was going to be a more dramatic break than it actually was.

The epoxy filled repair broke most dramatically, again at the repair joint.

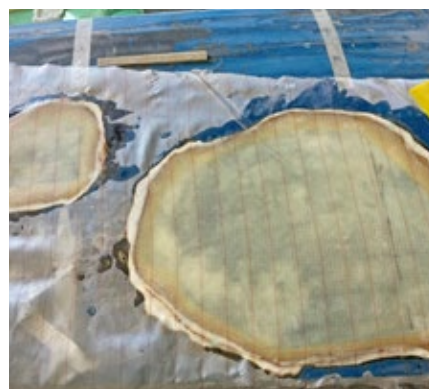
Fiberglass in place with release fabric.

It's a good idea to apply 879 Release Fabric over the final layer of fiberglass. Cut the release fabric several inches larger than the repair area and smooth it in place over the patch. To remove excess epoxy and smooth the patch, drag a plastic spreader over the release fabric, pressing firmly. Before the epoxy cures, use a beveled mixing stick or a paper towel to remove any excess epoxy from the surrounding areas. Allow the patch to cure thoroughly.

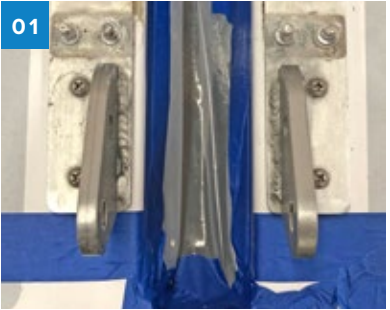
I received a call from a friend of mine who owns a 2004 Farrier F33RX folding trimaran, the 33' *Nelda Ray*. This sailboat is a frequent competitor in regattas on the Great Lakes. The aluminum mast was compressing the deck and causing laminate failure. I told my friend I'd figure out what went wrong and then fix it so it would never happen again. I'll outline the process I used to make this successful repair.

The deck had been fabricated with a few layers of lightweight fiberglass over high-density foam core, with minimal layers of fiberglass inside of the hull. The high loads from the mast bearing down on the aluminum mast step had compressed the foam core, leading to fatigue damage over the years.

01 The aluminum mounting brackets on the mast step.

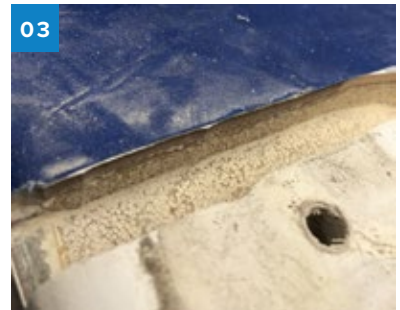
and examined how the deck was constructed. Using a router with a plunge tip bit cutter, I removed a portion of the deck but left the inner fiberglass skin intact. This made the problem easy to see: the laminate damage occurred because the load was too great for the core.

03 A router was the best tool for removing the high-density foam core.

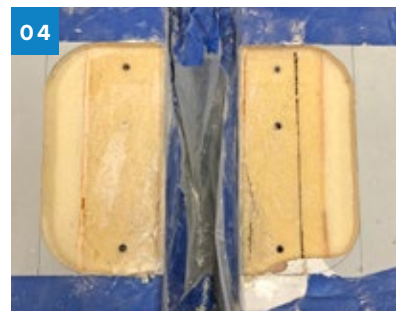
04 To make room for the G-10 panel, I removed the high-density foam with a router.

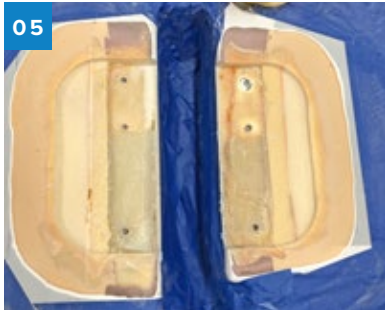
05 The fiberglass laminate was beveled around the perimeter of the cutout area. The foam was removed under the G-10 panel although some foam remained when this image was taken.

After the Six10[®] cured, I used a grinder to taper a 12:1 bevel around the perimeter of the outer fiberglass skin on the deck. In order to replace the damaged laminate, I cut five patches of 1708 biaxial fiberglass cloth in graduating sizes. I used WEST SYSTEM[®] 105 Resin and 206 Slow Hardener[®] to apply these patches. I made each fiberglass patch ½" smaller in all directions. I wet out the patches with epoxy and applied the largest patch first, followed by four consecutively smaller patches to match the original thickness. I then applied 2-3 fill coats of epoxy.

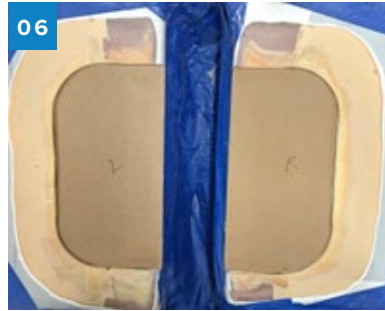
06 Thin cardboard was used to make a template for cutting the G-10 panels.

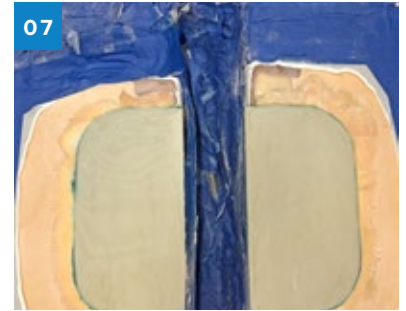
07 5/8" G-10 panels were bonded to the deck with Six10 Thickened Epoxy Adhesive.

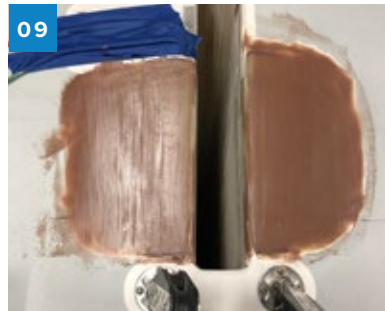
09 WEST SYSTEM 105/206 thickened with 407 Low-Density filler was used to fair the repair with the existing deck.

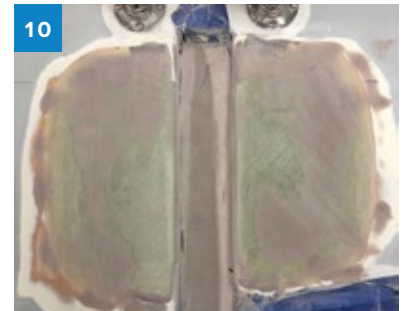
10 The 105/206/407 fairing compound cured, sanded smooth and ready for paint.

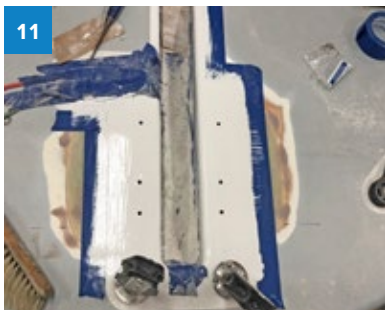
11 The repair area was taped off before applying white paint.

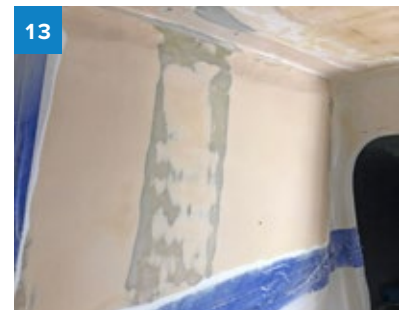
13 80-grit was used to sand away the paint on the daggerboard case.

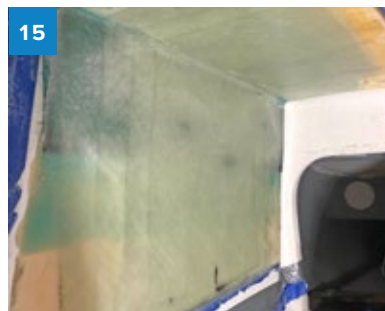
15 Four layers of 1708 were applied over the panels with 105/206.

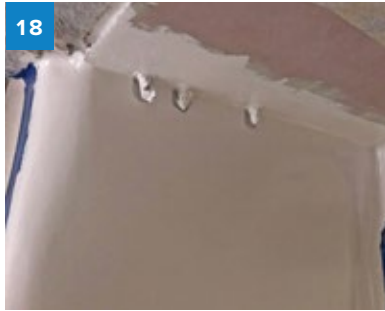
18

The surface was painted with flat white paint to finish the repair.

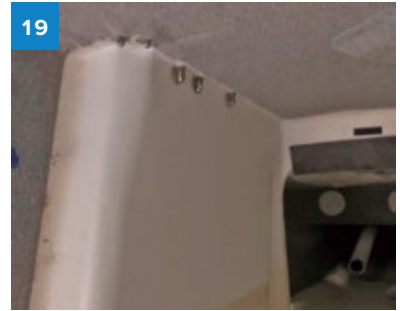
19

The repair finished with paint.

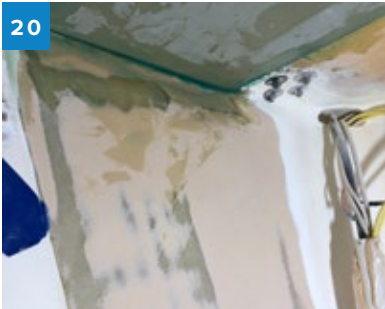
20

The port side G-10 panel was bonded underneath the deck with Six10.
