# EPOXY<sup>®</sup> WORKS

**BUILDING, RESTORATION,  
& REPAIR WITH EPOXY**

**ISSUE  
NO. 60**

**SPRING  
2025**

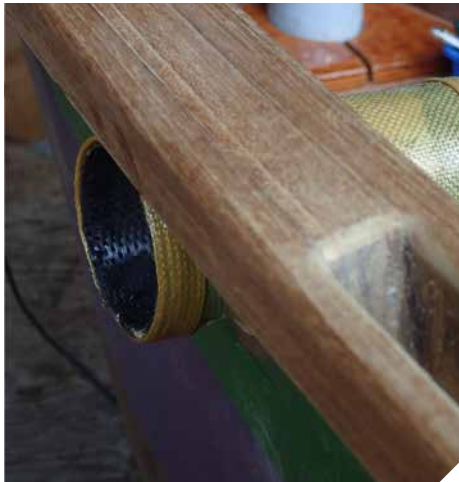
**TOP:**

Kevlar in the outhaul system. The outhaul car is a Kevlar molding with a block for a double-purchase. The boom's end fitting is Kevlar, eliminating a sheave and almost all metal, while reducing length and mass.

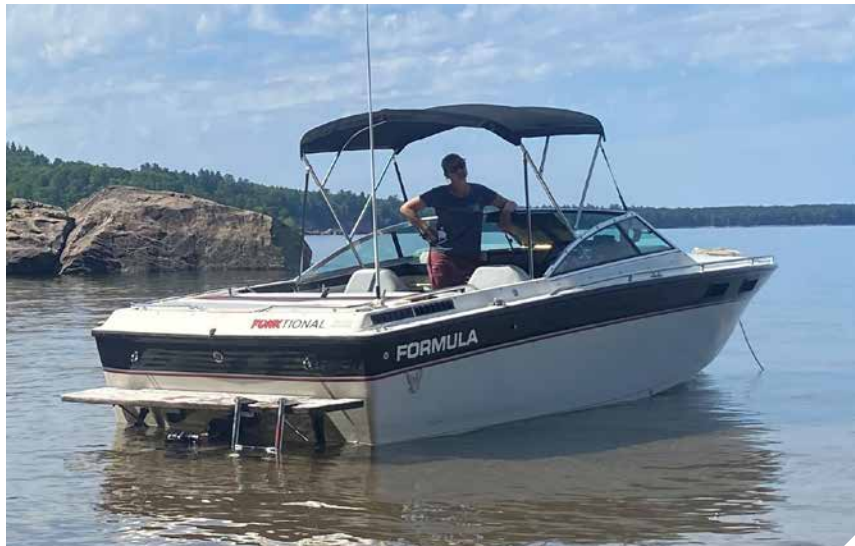
## ABOVE:

1986 Formula 242, *Funktional*.

My 1986 Formula 242, *Funktional*, has been taking me around the Great Lakes and beyond for 20 years. With over 2,500 total hours running time on the hull, and having been trailered at least 100,000 miles since I have owned her, the bottom has had its share of choppy waves and Michigan potholes. What I noticed this year was significant growth of longitudinal gelcoat cracking near the keel on the forward portion of the bottom. The cracks were at the forward end of the long primary trailer bunks. After looking at the cracks I made some notes to determine the cause and solution:

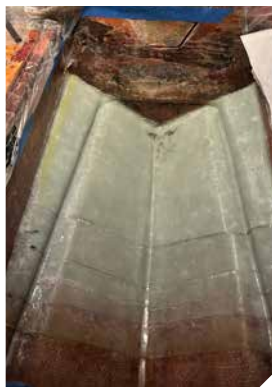
### LEFT:

The forward six layers of fiberglass were all applied in one session. Each layer stepped back so the butt joints would be staggered.

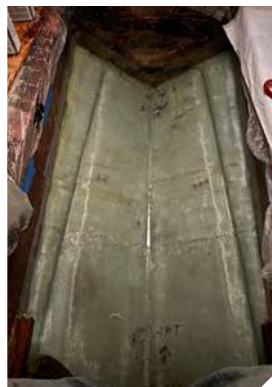
### MIDDLE:

Once cured, and the surface prepared, the aft layers could be applied.

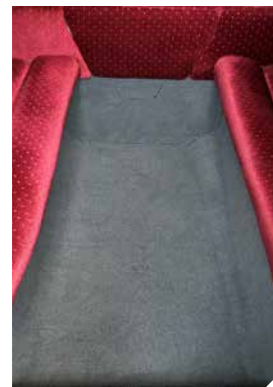
### RIGHT:

The was carpet reinstalled, looking as good as new.
