# **EPOXYWORKS**.

BUILDING, RESTORATION & REPAIR with EPOXY Number 31 Fall 2010 Forum

#### In this issue

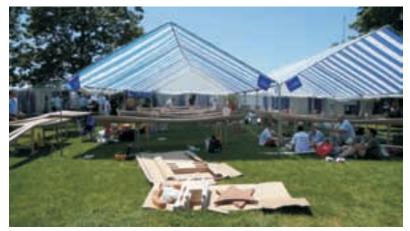
Temporary and permanent bulkheads are wired in place. By the end of day one, all of the strakes were stitched in place and the laps were glued with Six10 Adhesive.

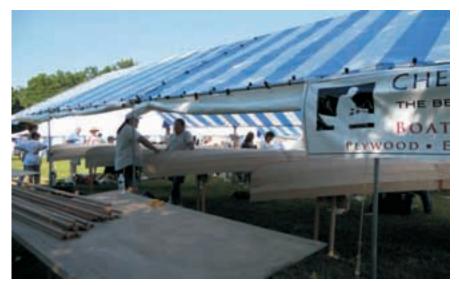
The very practical, puzzle joints make it easy to turn short planks into long planks.

With the copper stitching removed and the outer lap joints filleted, the hulls are ready to be rolled upright again to install the inwales and outwales before the end of day two.

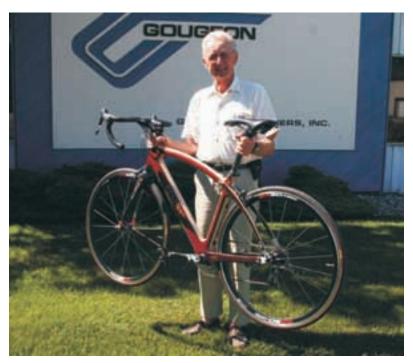
Meade Gougeon shows off his lightweight Renovo Hardwood Bicycle. The custom bike is made of curly maple outlined with a pinstripe of wenge. The outer laminate is padauk. The stays' outer layers are wenge with centers of Port Orford cedar.

Meade commissioned Renovo to build a bike for him of wood and WEST SYSTEM<sup>®</sup> Epoxy, and the results were beautiful. Renovo team member Ken Wheeler describes Meade's bike frame: "The center wood is curly maple out-

lined with a pinstripe of wenge. The outer laminate is padauk. The stays are outer layers of wenge with centers of Port Orford cedar. The front triangle is as stiff as carbon Cervelo S2 (very stiff). The rear triangle has about 80% of the stiffness of S2 to provide a smoother ride."

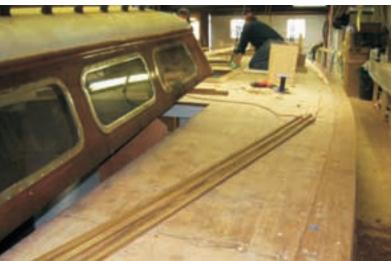
Two layers of ¼" plywood are vacuum bagged over cedar planking. Note the staggered joints in the plies.

The deck house being fitted to the new deck.

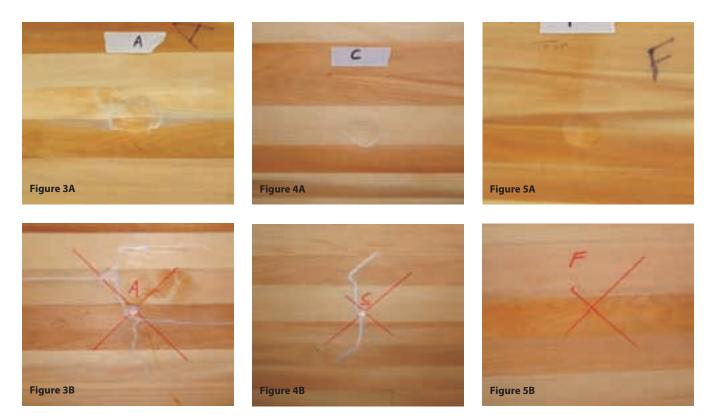
The pictures of Panel A, one layer of 6oz fiberglass cloth oriented at 90° on each side, show a very small area of damage on the impact side (*Figure 3A*)but the reverse side (*Figure 3B*) has a large laminate failure. Much of the laminate failure occurred in the fibers oriented across the wood grain, indicating that additional cross grain strength would be beneficial. Panel C (*Figure 4A, impact side*)

and 4B, reverse side), which had an additional layer of 6oz cloth on each side oriented  $45^{\circ}$  to the wood grain, retained significantly more stiffness than Panel A. The other panels with fiberglass oriented at  $45^{\circ}$  to the wood grain also retained more stiffness than panels with the same amount of fabric oriented at 90° to the wood grain. The combination with the best balance between weight and damage resistance appears to be Panel F (*Figure 5a, impact side and 5B, reverse side*). It had almost the damage tolerance of Panel G, which did not lose any stiffness from the impact, but Panel F weighs much less.

It is interesting to note the amount of damage that occurred on the side opposite of the impact. If this had been an impact on an actual hull, the visible damage on the outside surface would be very misleading. As we have suggested for both wood strip construction and balsa and foam cored composites, be sure to thoroughly investigate for damage. A small divot on the outside could indicate significant damage on the opposite side. Looking at Panel A in Figure 3A, the impact certainly does not indicate the amount of damage on the opposite side that resulted in a 37% increase in deflection (*Figure 3B*).
