EPOXYWORKS®

BUILDING, RESTORATION & REPAIR with EPOXY
Number 54 ■ Spring 2022

BO-PEEP II 75-Year Refit

Wet Rudder Repair

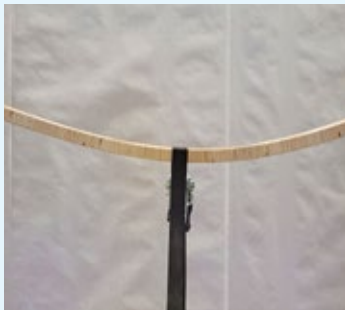
The control sample panel with the all-balsa core just folded and cracked in half when it broke, because of the concentrated area of bending or loading. The others all broke at the edge where the balsa core met the alternate core material and fractured the fiberglass on top in compression.

The balsa cored control sample cracked in half when it broke.

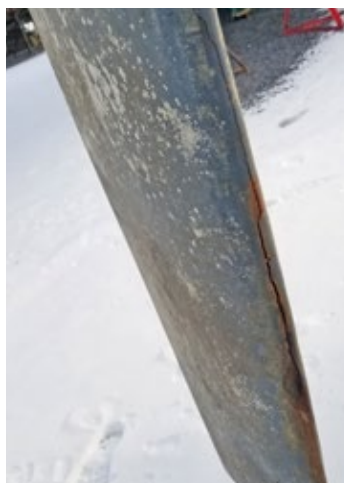
We found two smaller delaminated spots on one side of the rudder and a sizeable one on the other, along with a 6" crack near the rudder shaft. After drilling a few $\frac{3}{8}$ " drainage holes through the fiberglass skin and into the foam core, we saw that it was still in good shape even though the foam was wet.

BOTTOM:
The cracked fiberglass rudder.

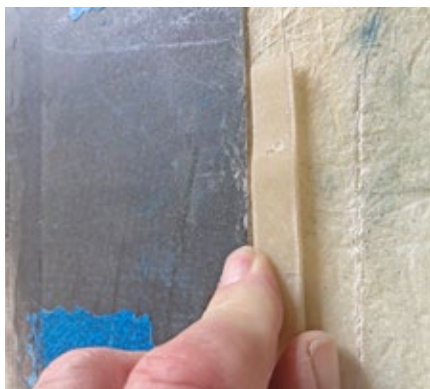
Thickness gauge.

The variance in thickness at different levels of the gauge reflects both the

fabric thickness and how you laid up the laminate, making these gauges especially accurate. You can laminate the repair area in the same way you laminated the gauge to reach the same thickness results. Using my laminate thickness gauge, I decided that two layers of 17 oz. 737 Biaxial Fabric would be closest to the original laminate thickness. Any low areas could be filled with WEST SYSTEM Epoxy and 407 Low-Density filler. High spots would be minimal and easily sanded fair.

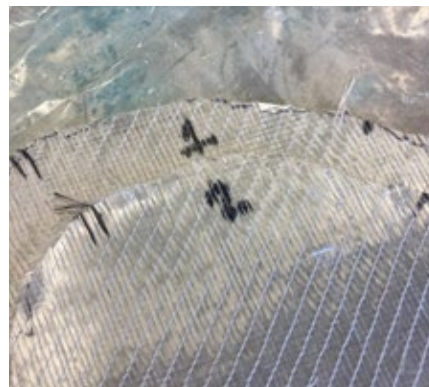
Alignment marks.

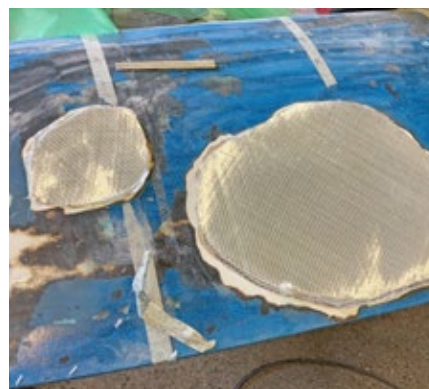
We traced the pattern on the fiberglass before cutting it out.

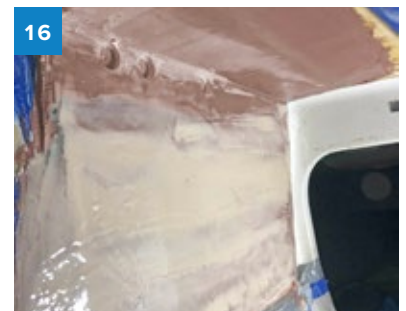
16 The surface was faired with 407 Low-Density and 410 Microlight® filler.

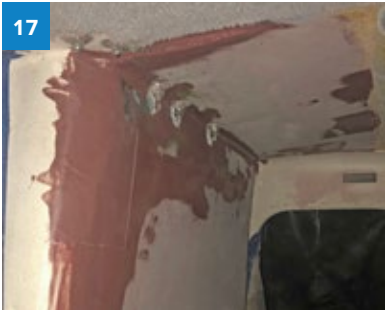
17

Applying the finishing touch-ups with 407 Low-Density filler to the starboard side.
